Revision Guide for AMD Family 15h Models 00h-0Fh Processors

Publication # 48063	Revision: 3.04
Issue Date: November 2011

Advanced Micro Devices

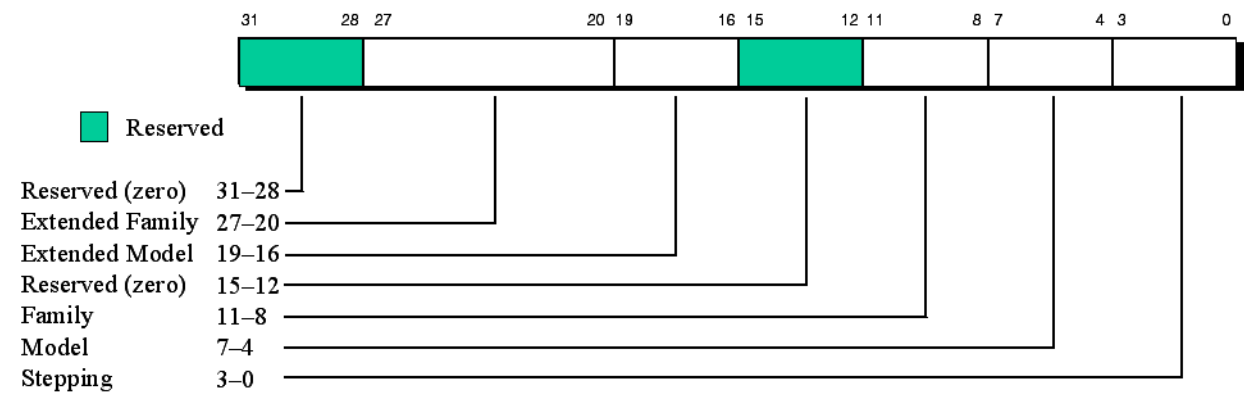
Figure 1. Format of CPUID Fn0000_0001_EAX

A processor revision is identified using a unique value that is returned in the EAX register after executing the CPUID instruction function 0000_0001h (CPUID Fn0000_0001_EAX). [Figure 1](#) shows the format of the value from CPUID Fn0000_0001_EAX. In some cases, two or more processor revisions may exist within a stepping of a processor family and are identified by a unique value in D18 F4x164 Fixed Errata Register (see [D18F4x164 Fixed Errata Register](#)).

Figure 1. Format of CPUID Fn0000_0001_EAX9
